Repairhints

Service-Level 3 & 4

3510 / 3510i

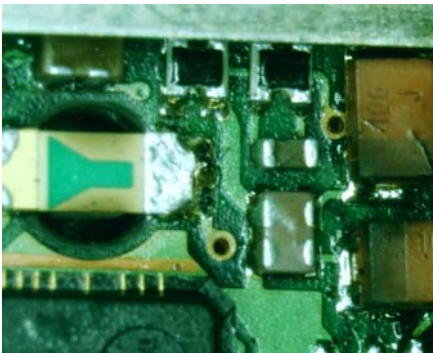
All replaceable (not underfilled) μ BGA components must be renewed after removing. Reflow with uncontrolled hot air fan is strictly forbidden! μ BGA must only be soldered with NMP approved μ BGA rework machines (e.g. Zevac / OK-Metcal / Martin) to get durable soldering joints.

"rework" done with uncontrolled hot air

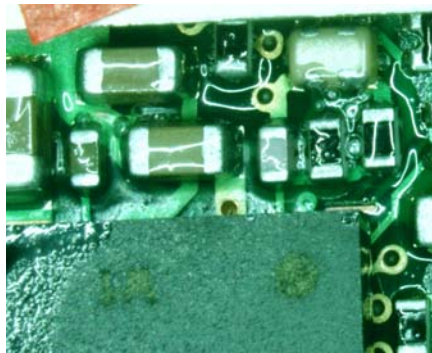
After removing a μ BGA check soldering points, if necessary rework oxidated solderings (broken balls) carefully by tinning these areas with few flux and a hot soldering iron. Before placing a new component remove the tin and clean the PCB, e.g. with help of solder wick and flux cleaner such as "Kontakt LR". Use only recommended Fluxtype and an appropriate amount of it – avoid drowning the PCB in flux as this will result in additional faults!

PCB drowned in flux

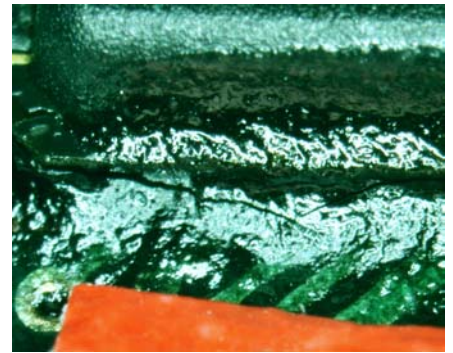
Also check underfilled parts for broken underfill material below. In this case carefully evaluate possible repair actions as the phone probably was exposed to strong mechanical stress.

broken underfill of an μ BGA part

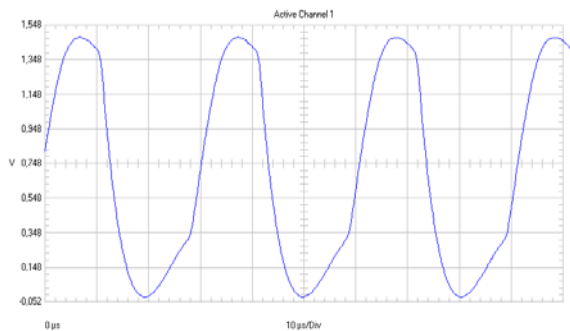
Figure 1: 32.768kHz at C209

- Check DC-voltages at C209 (0.59V) and C210 (0.42V). If voltages are not ok check lines for shorts to ground. It also is possible that UEM D200 is defect.
- Change the crystal B200 if DC-voltages at C209 / C210 are ok but no 32.768kHz sinewave signal is measurable (see picture below).
Note that this signal is always measurable in MJS-37 jig even though the phone is switched off.

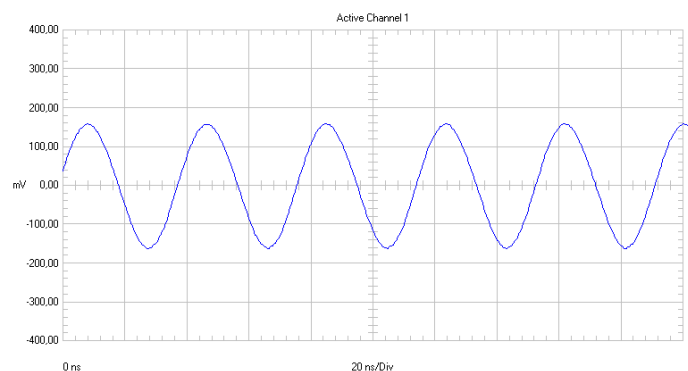
Figure 3: 26MHz at B600

- Check VR3 2.8VDC at C620.
- Check 26MHz sinewave signal at B600 (picture below). If it is not measurable check DC-voltage at both sides of crystal B600 that normally is 2VDC. In case that DC-voltage is missing Mjoelner N600 has to be changed. If voltage at crystal is ok but no 26MHz sinewave is measurable crystal B600 has to be exchanged.

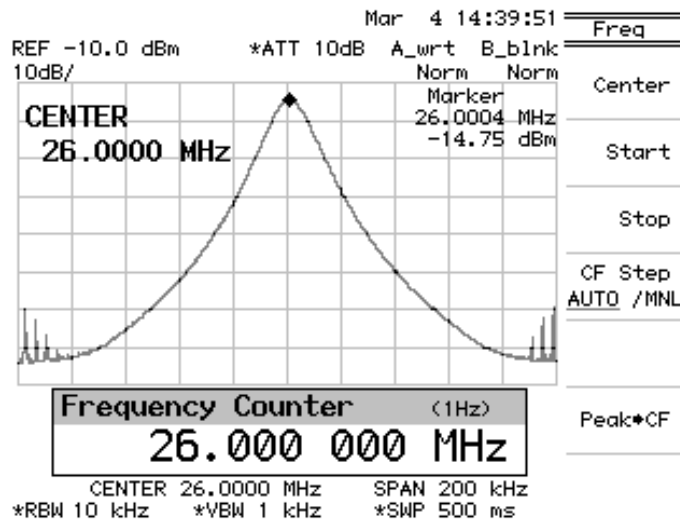
Figure 4: 26MHz at J425

- Check signal of 26MHz reference clock oscillator at J425 (see figure below).
If signal is not measurable (at least as a short pulse) but 26MHz sinewave at B600 is ok you have to exchange Mjoelner N600.
